# An Esthetic Alternative in Full-Coverage Restorations

## CASE STUDY

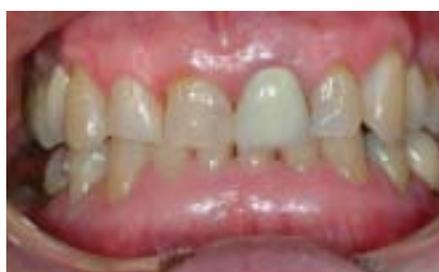
Figure 1—Anterior view of overbite.

A 74-year-old man presented with advanced wear on the buccal incisal and middle third of the lower incisors as a result of occlusal problems with posterior restorations, as well as a bulky opposing central incisor crown (Figures 1 through 3). With a class II occlusion and a moderate overbite, it was determined to only restore the lower incisors because the canines were relatively healthy and were presented with slight incisal wear. The lower left canine showed more considerable wear. Considering the patient's age as well as the canines' wear pattern, it was established the patient was not a grinder, but had a vertical chewing pattern. At this time, the patient only wanted to correct the esthetic problem with as conservative an approach as possible without compromising longevity.

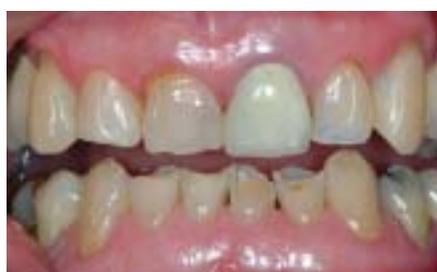
Figure 2—Anterior view of upper and lower anterior teeth.

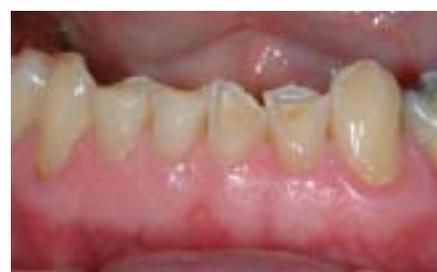
Figure 3—Anterior view of lower incisors showing advanced wear.

The patient's wear on the lower incisors was created by parafunctional habits in conjunction with an inadequate occlusion. Considering his wishes and age, it was agreed the upper central crown would be replaced after the completion of the four lower crowns. The patient admitted grinding his teeth in the past but had not done so for several years; therefore, a nightguard was not fabricated. This allowed for the improvement of an anterior guidance, while correcting the esthetic problem the patient presented with. A consideration for full/limited occlusal adjustment was presented to the patient, but it was declined.

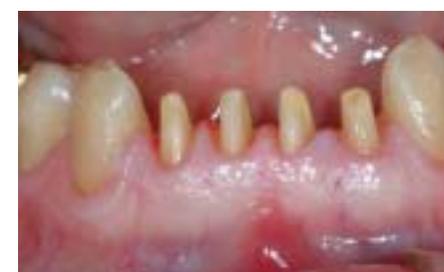
Figure 4—Lower anterior teeth prepared.

The teeth were prepared with a definitive 360° margin (Figure 4). A polyether final impression (**Impregum and Permadyne, 3M ESPE**) was made using the double cord technique, allowing for accurate reproduction of the margins in the impression material and the master model (Figures 5 and 6).

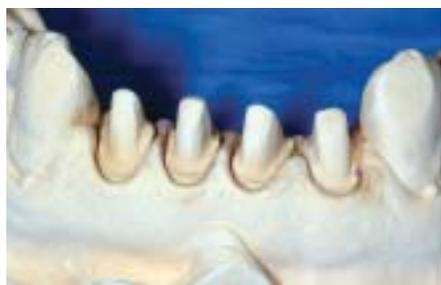
**Figure 5**—Buccal view of model work showing well-defined margins.

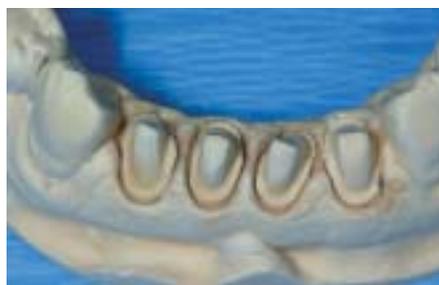
**Figure 6**—Incisal view of model work with sufficient tooth reduction for the fabrication of the final crowns.

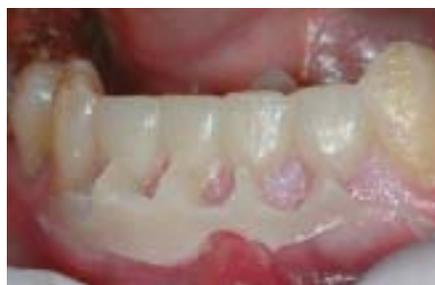
**Figure 7**—Untrimmed provisional in the mouth.

The provisional restoration was fabricated by using the diagnostic wax-up. A clear, vinyl polysiloxane **Affinity (Clinician's Choice Dental Products, Inc)** index was made from the diagnostic wax-up, extending one tooth beyond the prepared teeth. A "V"-shape cut was created in the polysiloxane index allowing for the escape of excess material as well as air (Figure 7). **EliteFlo Translucent (Bisco, Inc)** was used on

the buccal incisal third of the index. The teeth were air dried and lightly lubricated with petroleum jelly. **PerfectTemp (Discus Dental, Inc)** was syringed on the teeth as well as into the index. The index was slowly placed in the mouth and after 1 minute, it was light-cured to polymerize the flowable composite. The provisional restoration was removed from the mouth. The excess material was trimmed, final contours were established, and

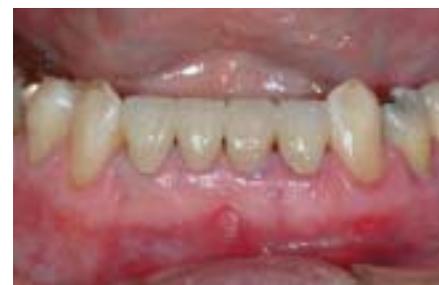
**Figure 8**—Completed and polished provisional in the mouth.

the occlusion was adjusted as necessary verifying centric occlusion, protrusive, and lateroprotrusive movements. The provisional restoration was polished and readied for temporary cementation. The gingival areas were lubricated with petroleum jelly to help facilitate in the removal of the temporary cement (Figure 8). An alginate impression was taken to aid the laboratory technician on what contours can be created with the final restorations.

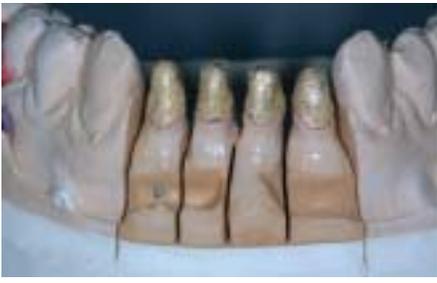
*Figure 9—Captek coping.*

The Captek copings were fabricated and cut back before porcelain application (Figure 9).

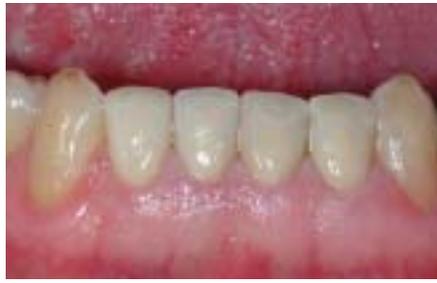
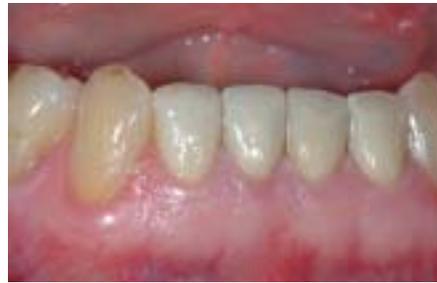
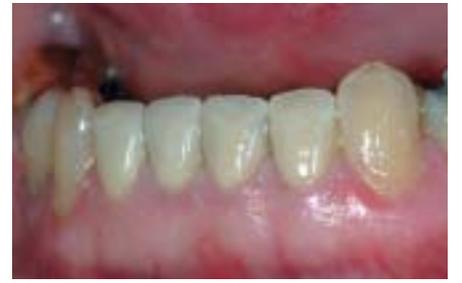
*Figures 10 through 12—Anterior, right, and left views of the final restorations.*

The provisional restoration was removed, and the preparations were disinfected with **Cavity Cleanser (Bisco, Inc)**, lightly dried, and the final restorations were cemented with **GC Fuji Plus (GC America Inc)**. The occlusion

was verified to confirm occlusal load distributed along with the natural teeth and the final crowns (Figures 10 through 12).
